<p>CORWIN ENGINEERING, INC. 200 W. BELMONT, SUITE E ALLEN, TEXAS 75013 (972)396-1200 TBPE FIRM #5951</p>			
<p>DEVELOPMENT PLANS FOR ROCKWALL DOWNS PHASE 1 ROCKWALL, TEXAS</p>			
<p>DETENTION POND DRAINAGE AREA MAP</p>			
DRAWN BY	DESIGNED BY	CHECKED BY	SHEET NO.
JOB NUMBER	DATE	SCALE:	15 OF 17
14046	JANUARY 2015	HOR: 1"=100'

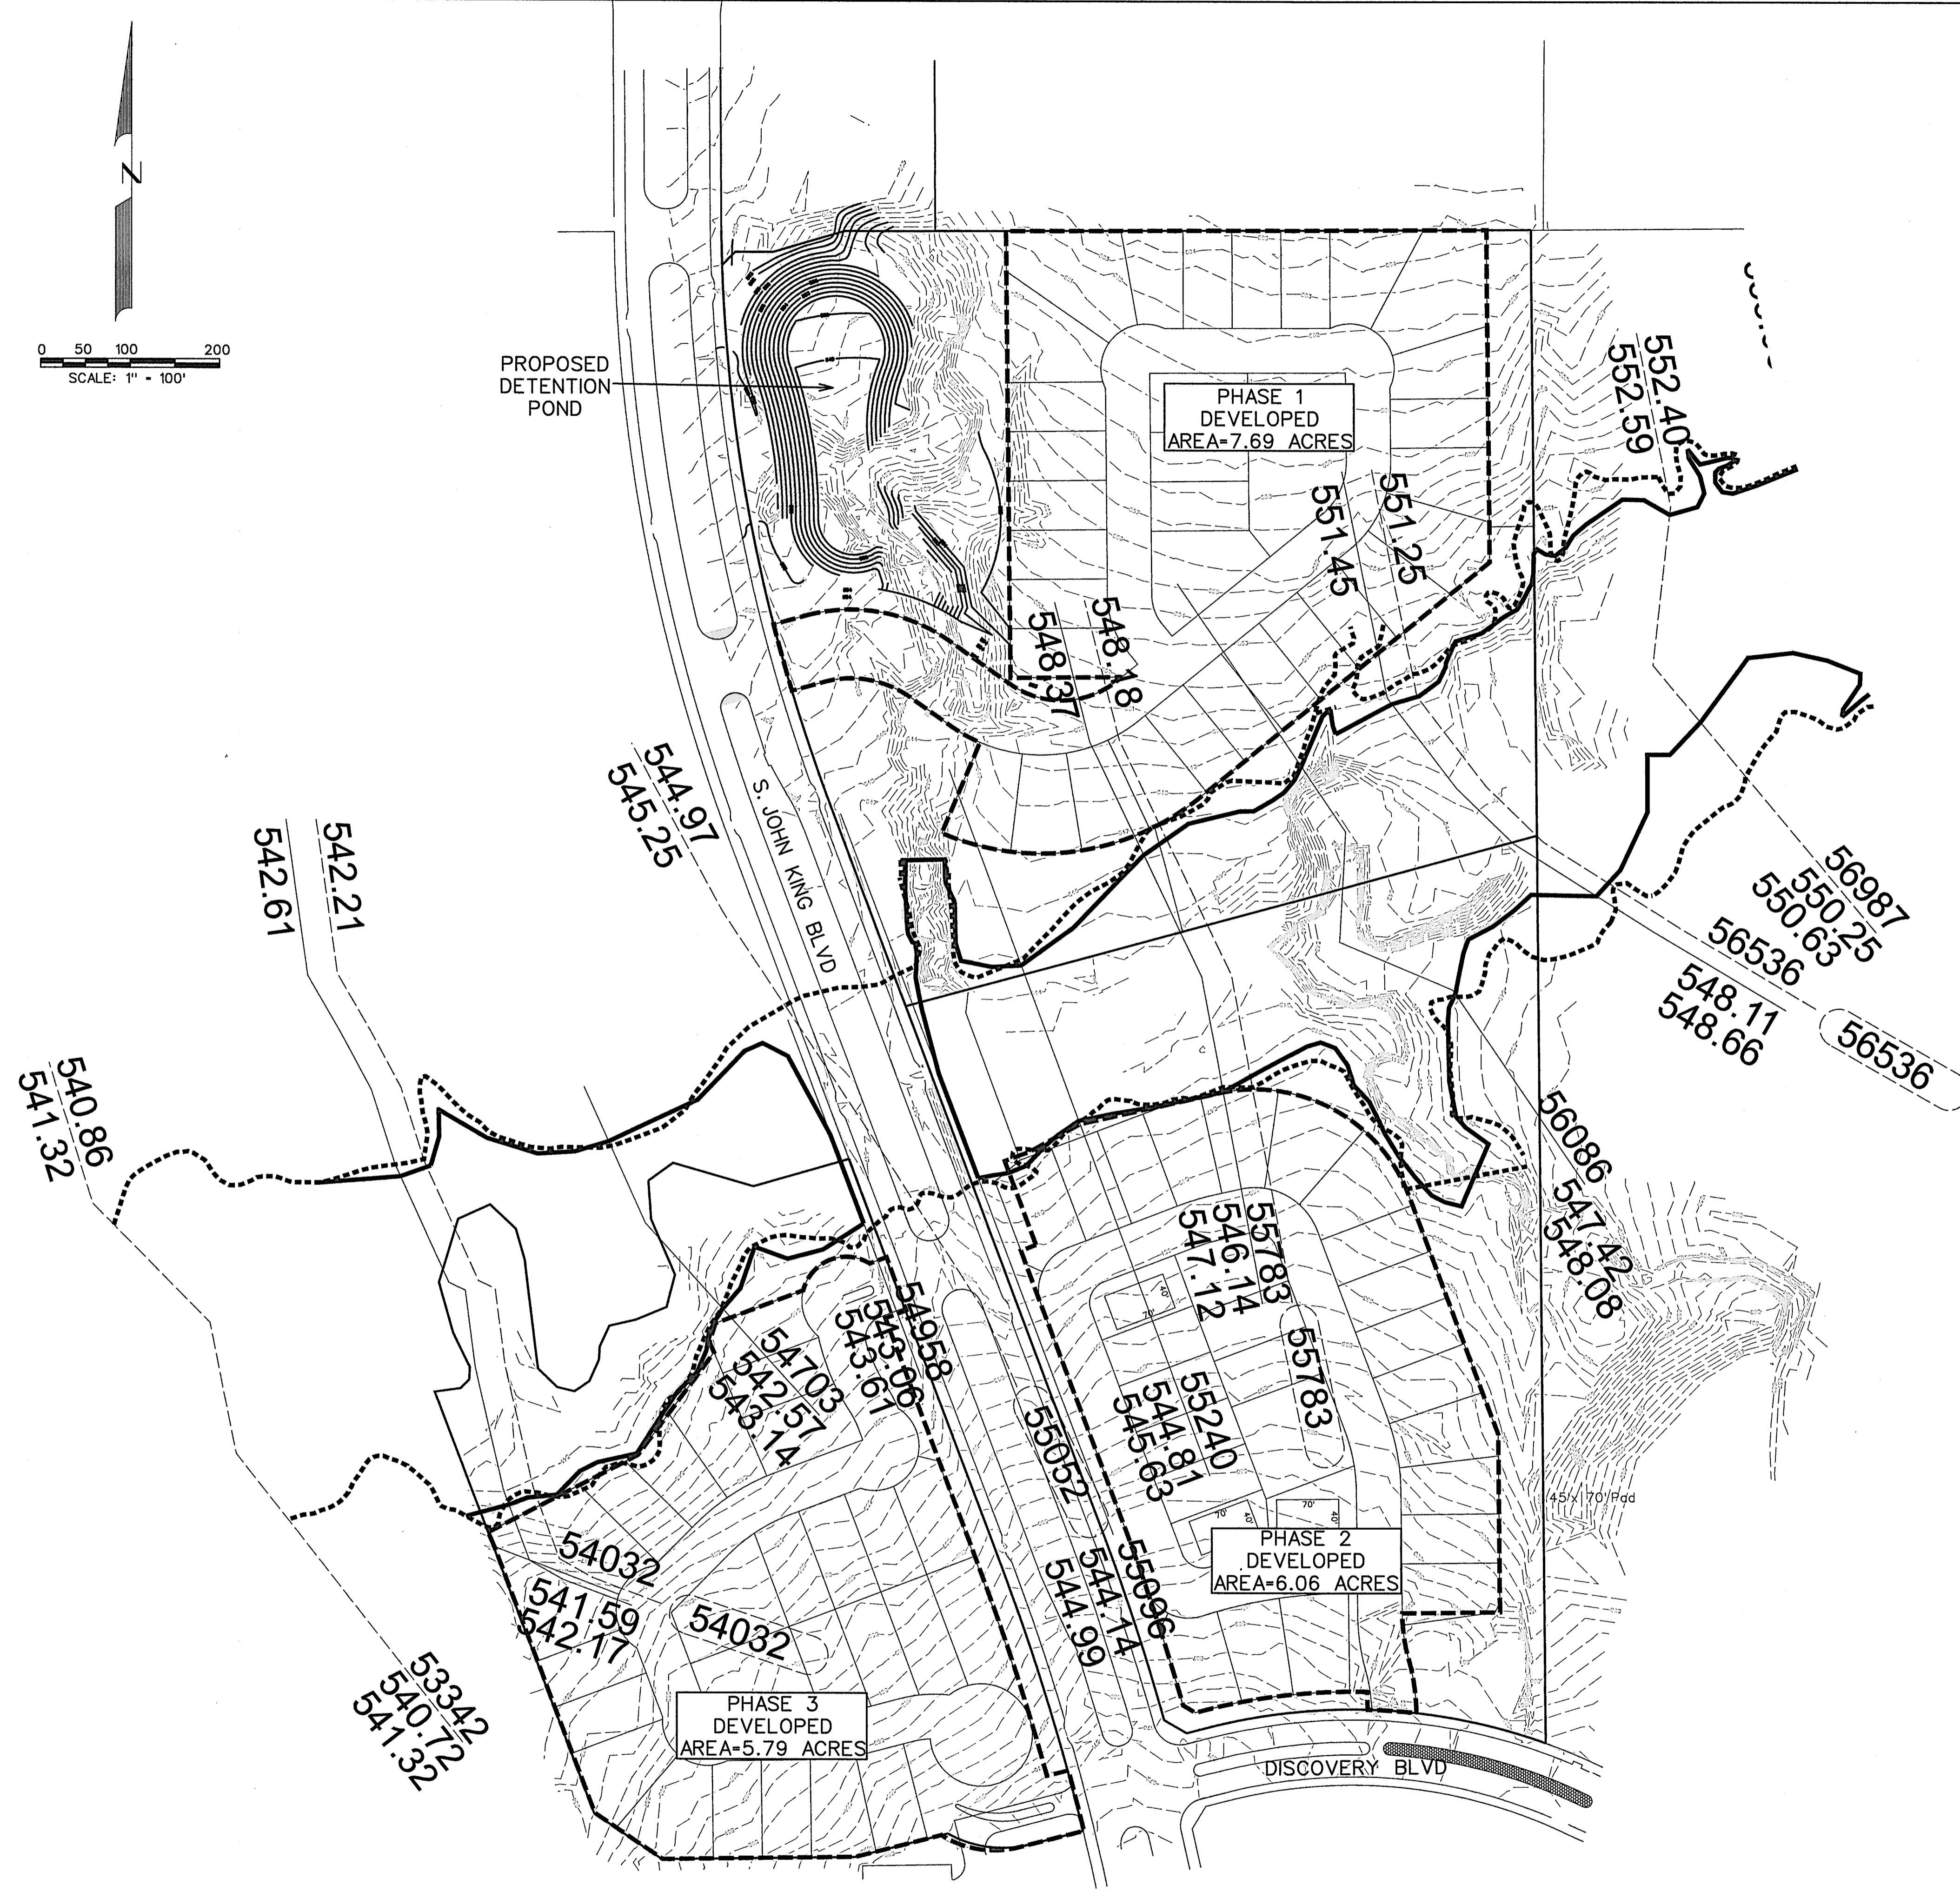
- 100 YEAR FULLY DEVELOPED CONDITIONS FLOOD PLAIN PER UPDATED GEOMETRY
 - - - 100 YEAR FULLY DEVELOPED CONDITIONS FLOOD PLAIN PER MDS
 - 100-YEAR FULLY DEVELOPED CONDITIONS WSEL FROM MDS
 - CROSS SECTION ID
- 547.85 55783
- 544.12 ← 100-YEAR WSEL BASED ON UPDATED GEOMETRY
- 544.91 ← 100-YEAR WSEL BASED ON UPDATED GEOMETRY AND FULLY DEVELOPED WATERSHED
- CROSS SECTION LOCATION (ORIGINAL LOCATION DASHED)
