AS BUILT PLANS 04/27/2001

LOT GRADING

LYNDEN PARK ESTATES PHASE 2

City Of Rockwall, Texas

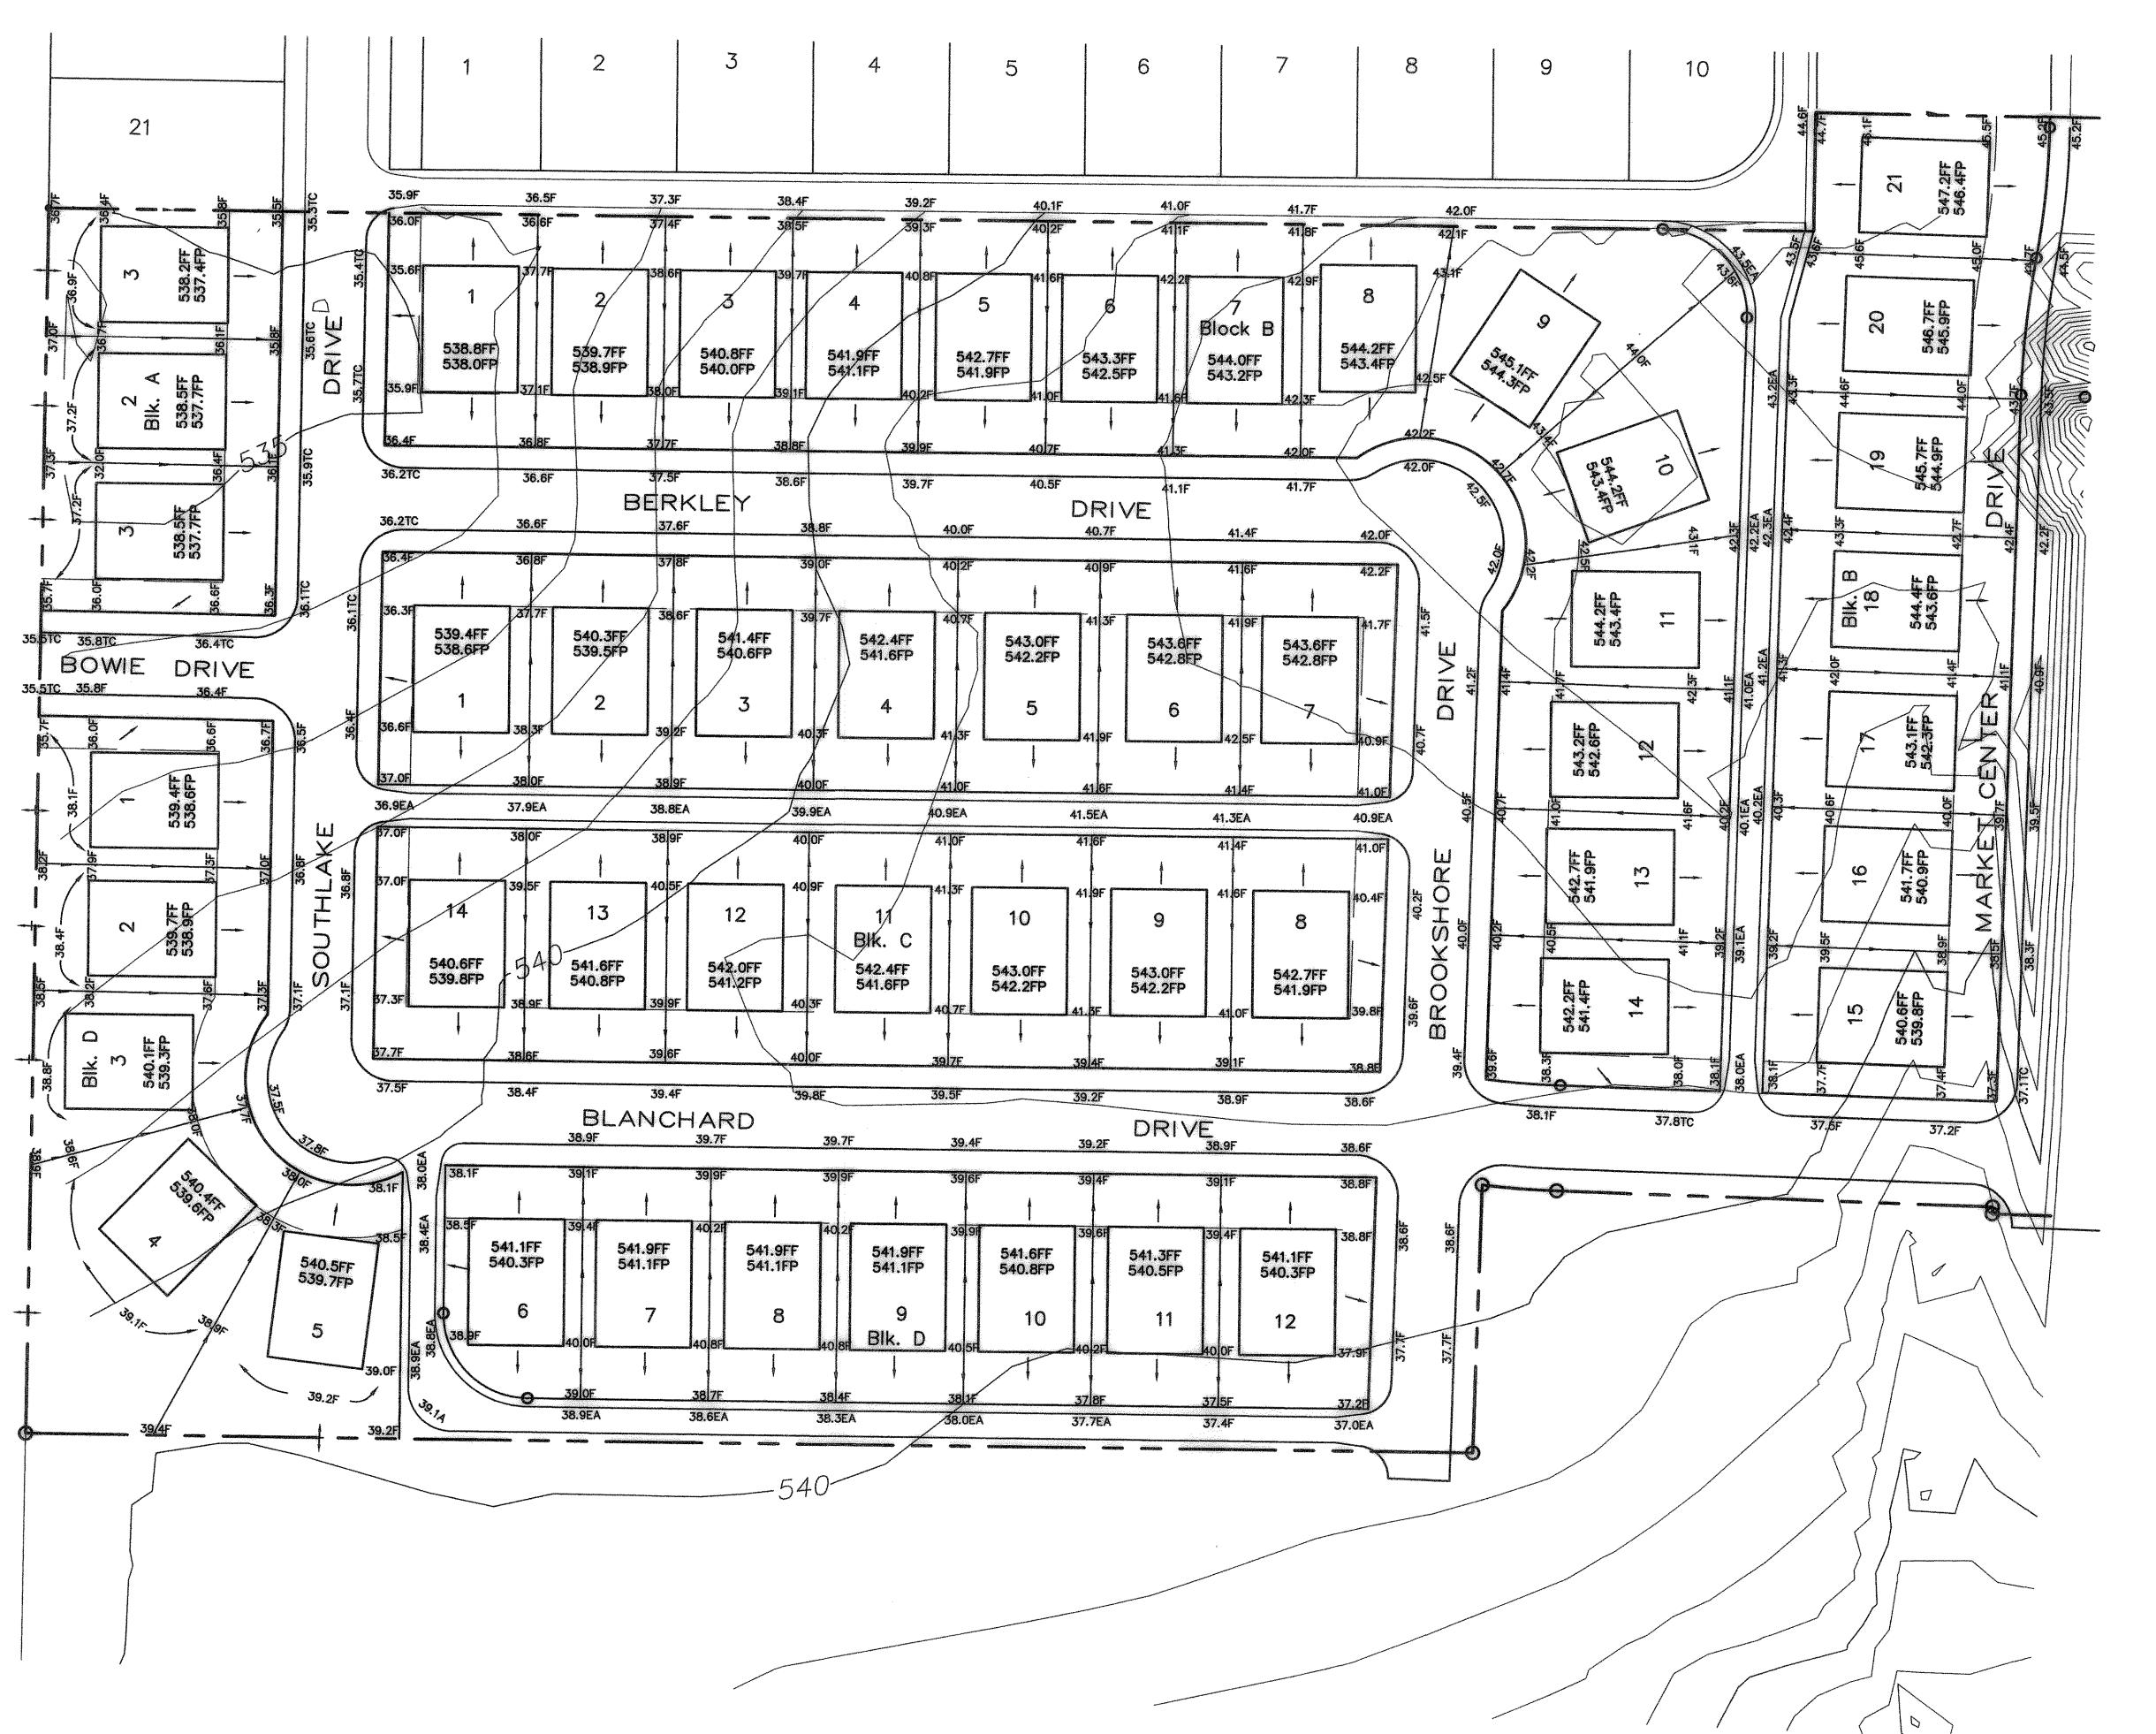
<u>Typical Lot Drainage Swale</u>
