Alley 'A1', Alley 'A2', Alley 'B', Alley 'D'

ALLEY PROFILES					
MEADOWCREEK ESTATES I					
City Of Rockwall, Texas					
TIPTON ENGINEERING, INC.					
6330 Broadway Blvd. ~ Suite C ~ Garland, Texas 75043					
DESIGN	DRAWN	DATE	SCALE	NOTES	FILE
T.E. Inc.	T.E. Inc.	11-98	1"=40' 1"=5'		4174
					13

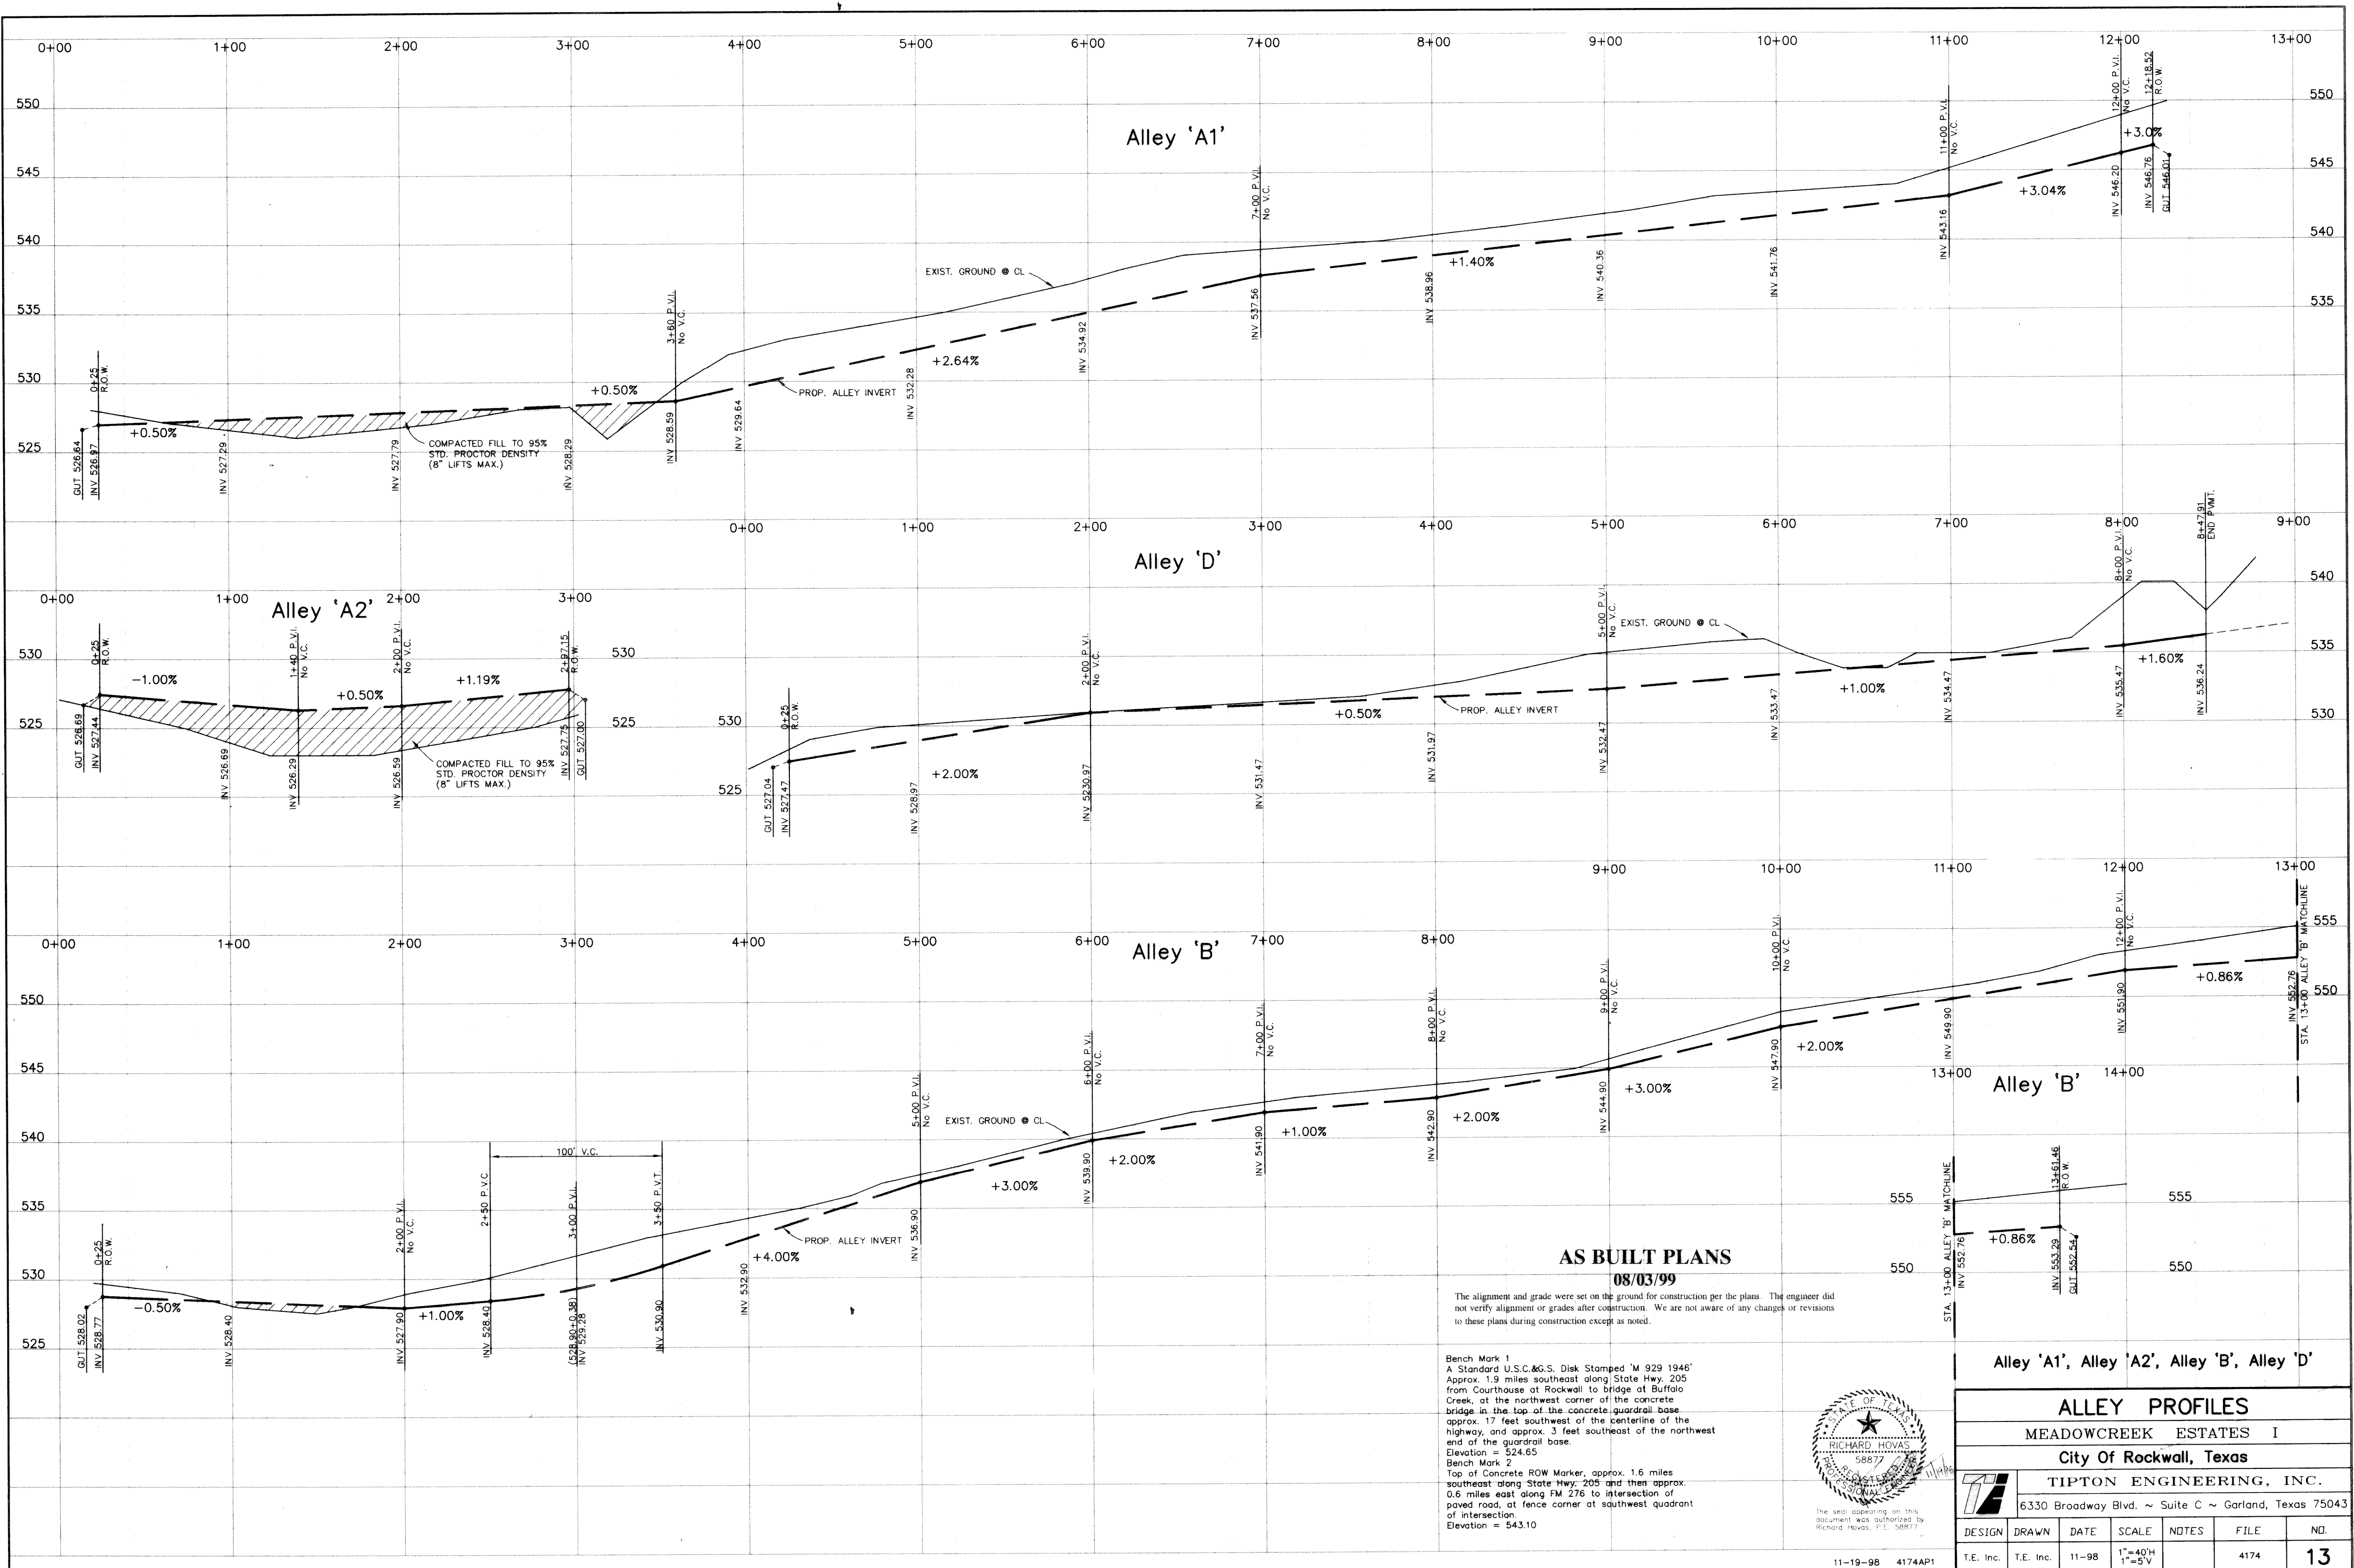
The alignment and grade were set on the ground for construction per the plans. The engineer did not verify alignment or grades after construction. We are not aware of any changes or revisions to these plans during construction except as noted.
