STORM SEWER PLAN						
MEADOWCREEK ESTATES II						
City of Rockwall, Texas						
TIPTON ENGINEERING, INC.						
6330 Broadway Blvd. ~ Suite C ~ Garland, Texas 75043						
DESIGN	DRAWN	DATE	SCALE	NOTES	FILE	NO.
T.E. Inc.	T.E. Inc.	8-98	1"=40' 1"=5'		4174	16

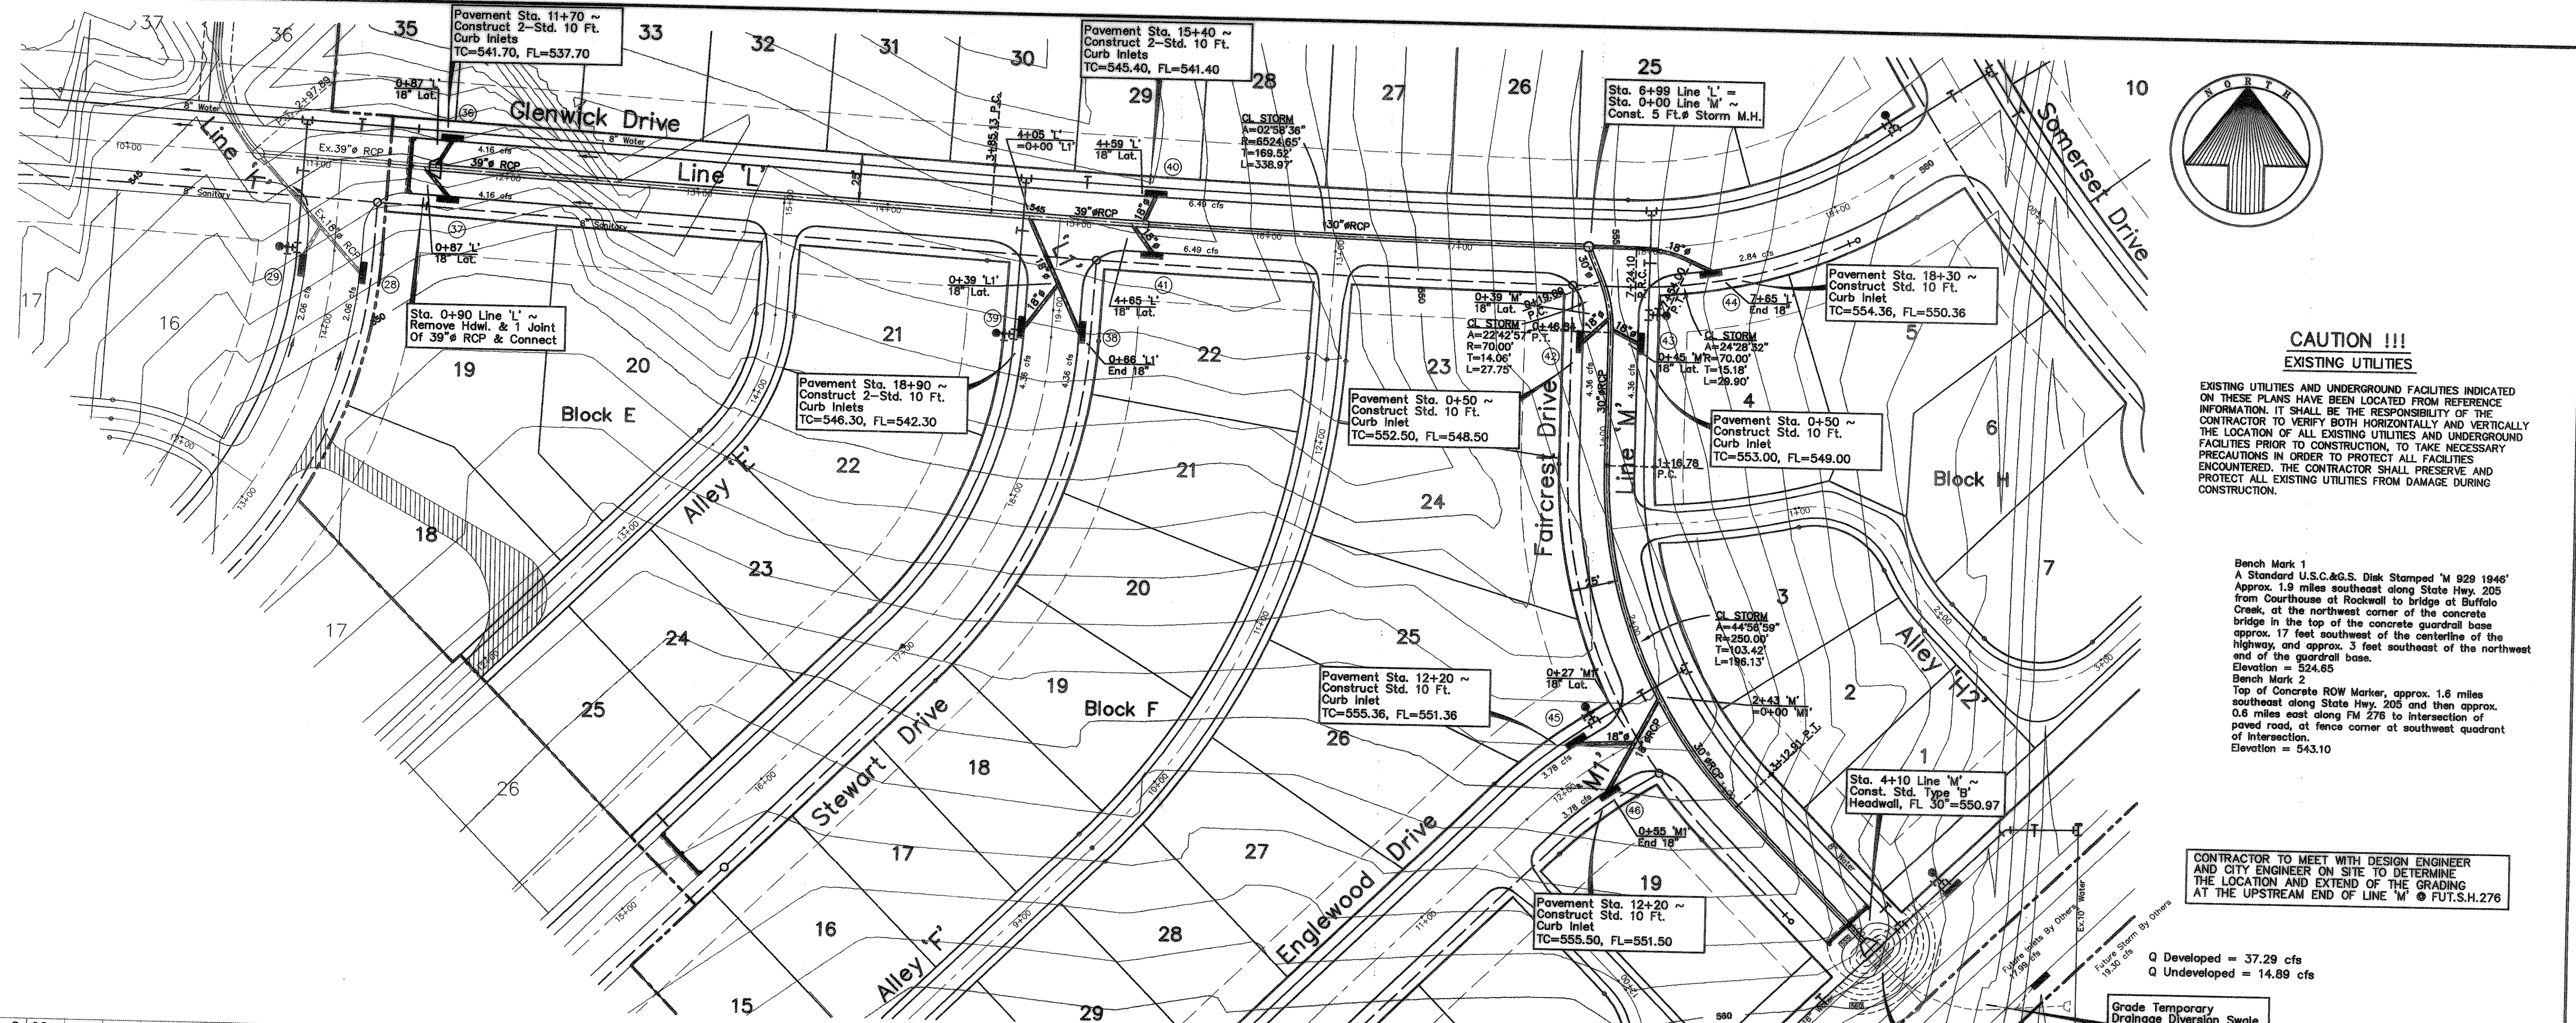
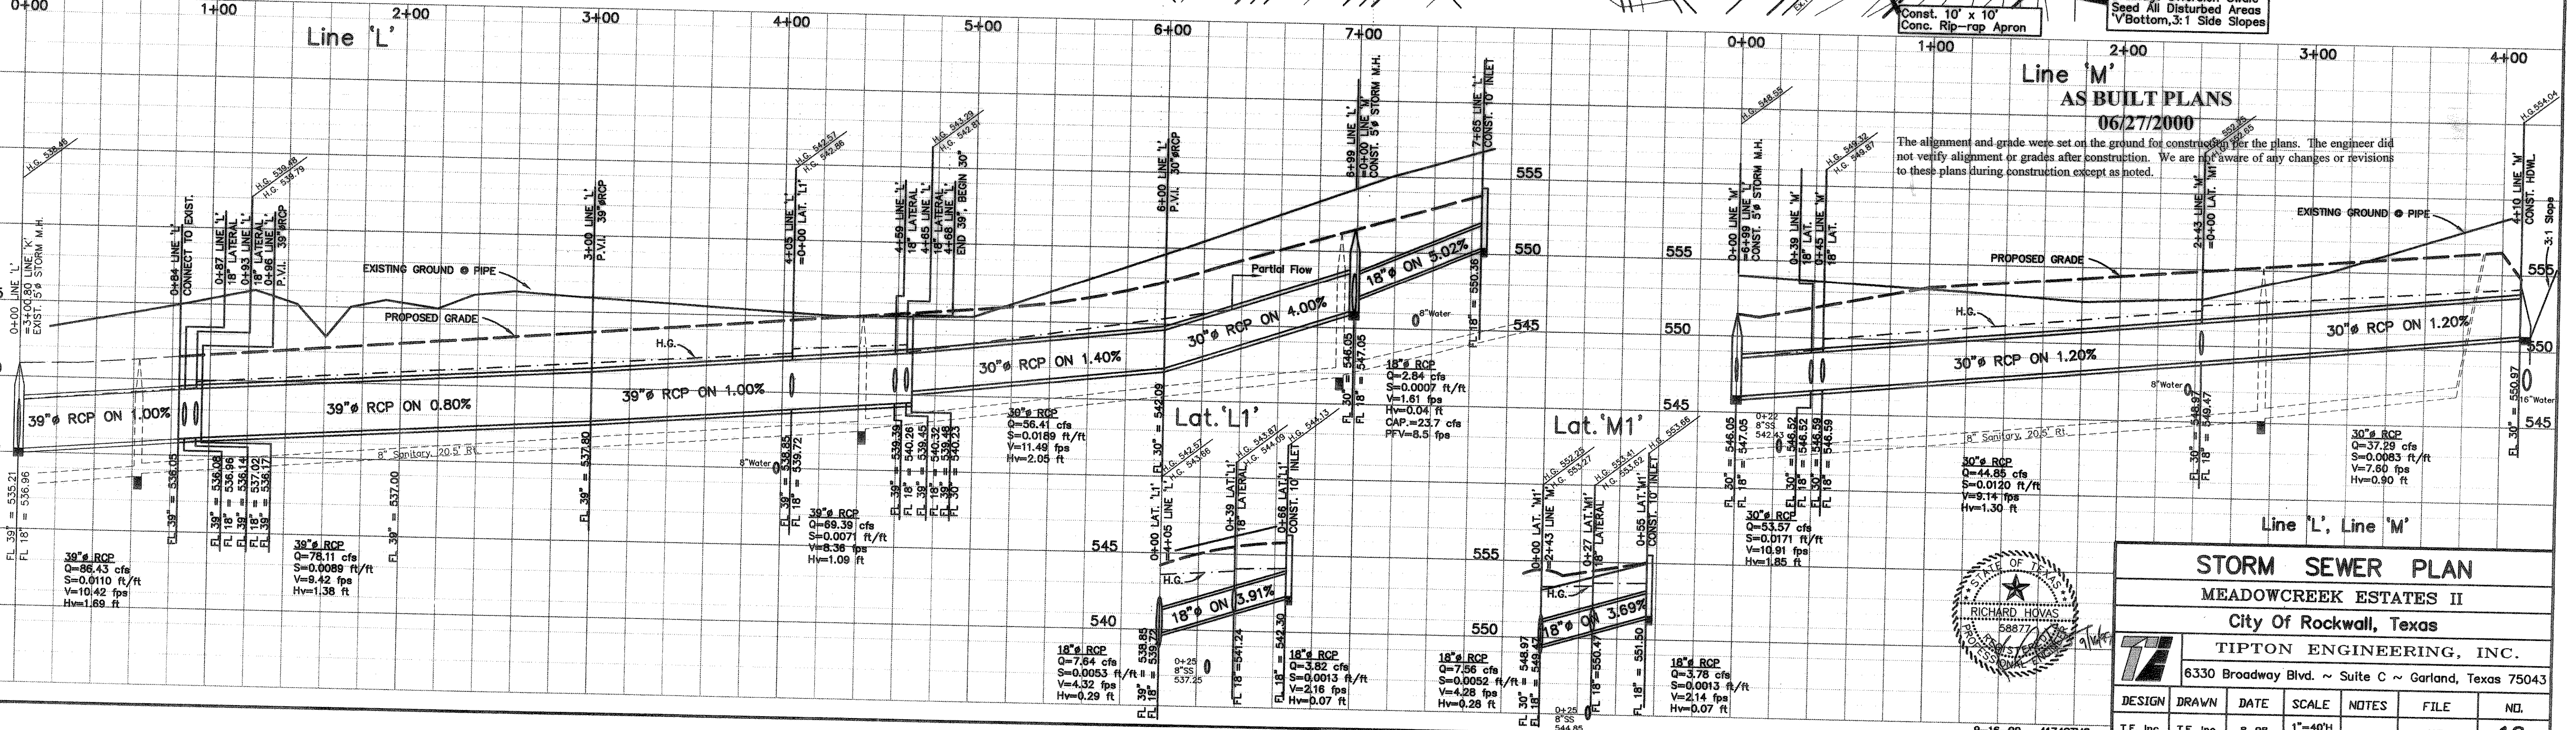
CONTRACTOR TO MEET WITH DESIGN ENGINEER AND CITY ENGINEER ON SITE TO DETERMINE THE LOCATION AND EXTEND OF THE GRADING AT THE UPSTREAM END OF LINE 'M' @ FUT.S.H.276

Q Developed = 37.29 cfs
Q Undeveloped = 14.89 cfs

Grade Temporary
Drainage Diversion Swale
Seed All Disturbed Areas
Bottom, 3:1 Side Slopes
