THE WOODMONT COMPANY

PLAZA AT ROCKWALL

**UTILITY PLAN F**

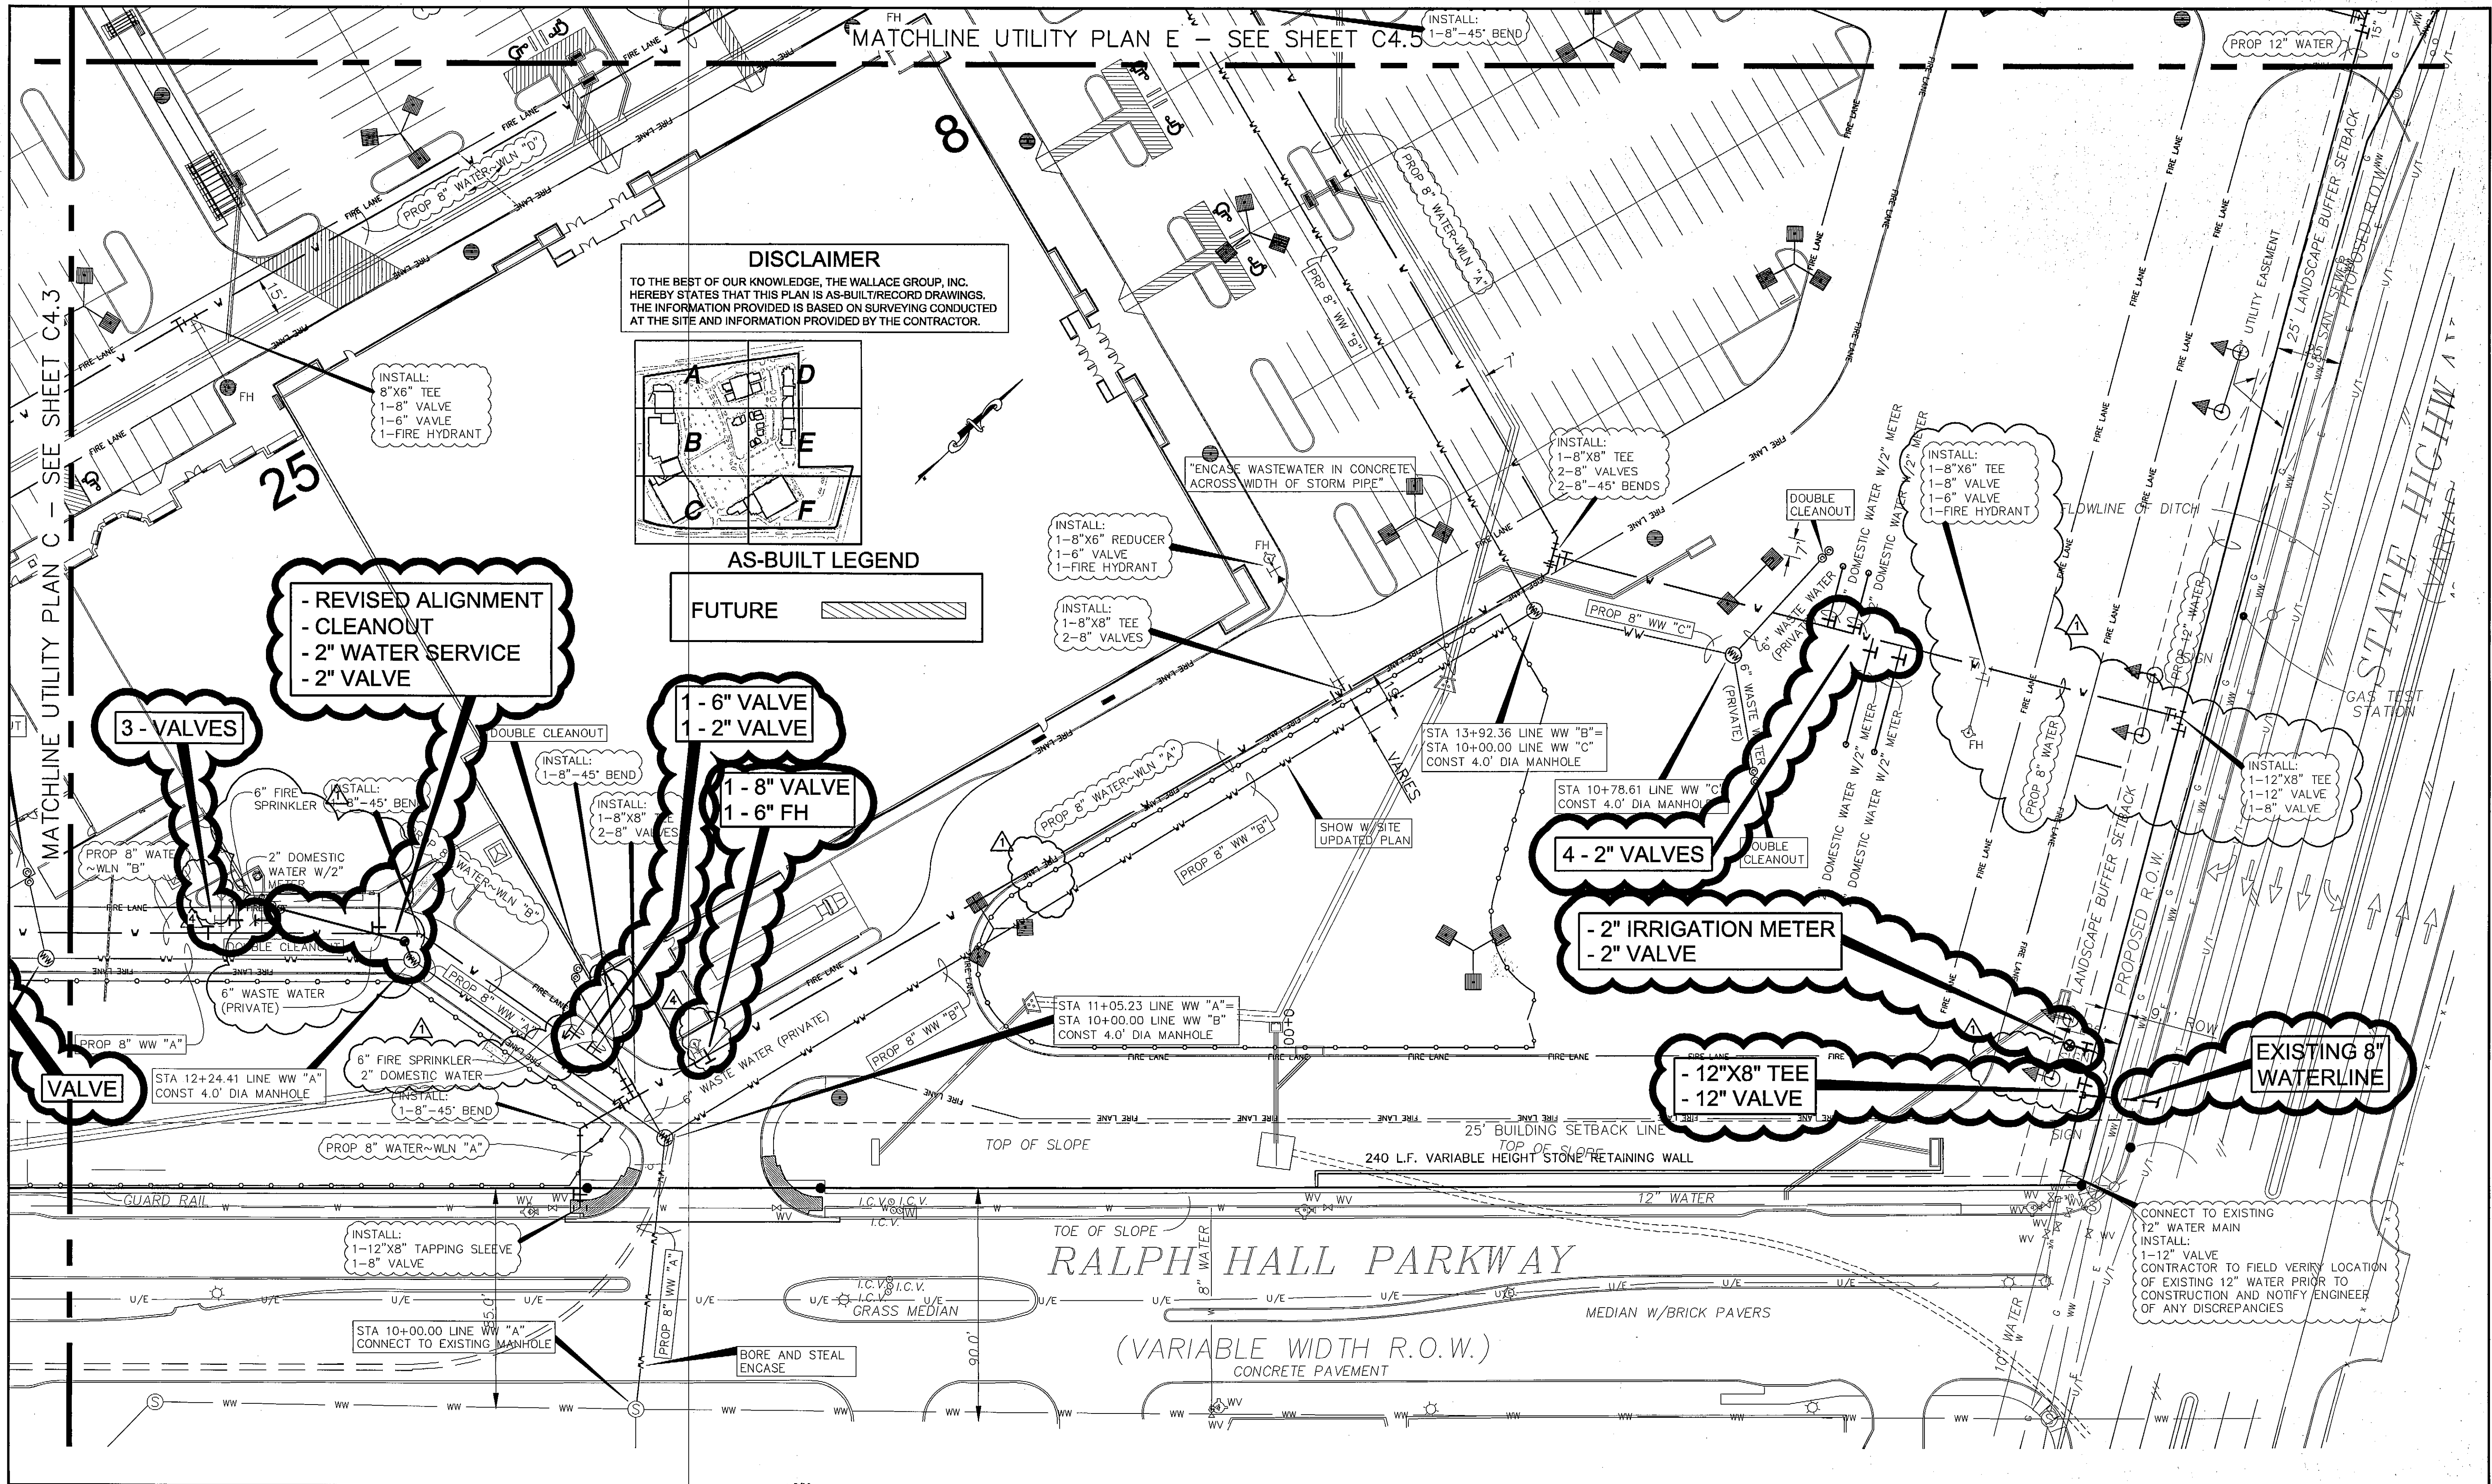
**REVISIONS**  
 - REVISED ALIGNMENT  
 - CLEANOUT  
 - 2" WATER SERVICE  
 - 2" VALVE

1 - 6" VALVE  
 1 - 2" VALVE

1 - 8" VALVE  
 1 - 6" FH

4 - 2" VALVES

- 2" IRRIGATION METER  
 - 2" VALVE

- 12"X8" TEE  
 - 12" VALVE

EXISTING 8" WATERLINE

REV	DATE	BY	DESCRIPTION
3-19-07		MM	Removed and revised fire hydrant locations
2-19-07		R33	Revised utility service connections & removed Fire Hydrants
