RECORD DRAWING

SANITARY SEWER PROFILE
ROCKWALL COMMUNITY HOSPITAL
HORIZON ROAD @ ROCKWALL PARKWAY
EDWARD TEAL SURVEY, ABST. NO. 207
CITY OF ROCKWALL, TEXAS

ROCKWALL COMMUNITY HOSPITAL

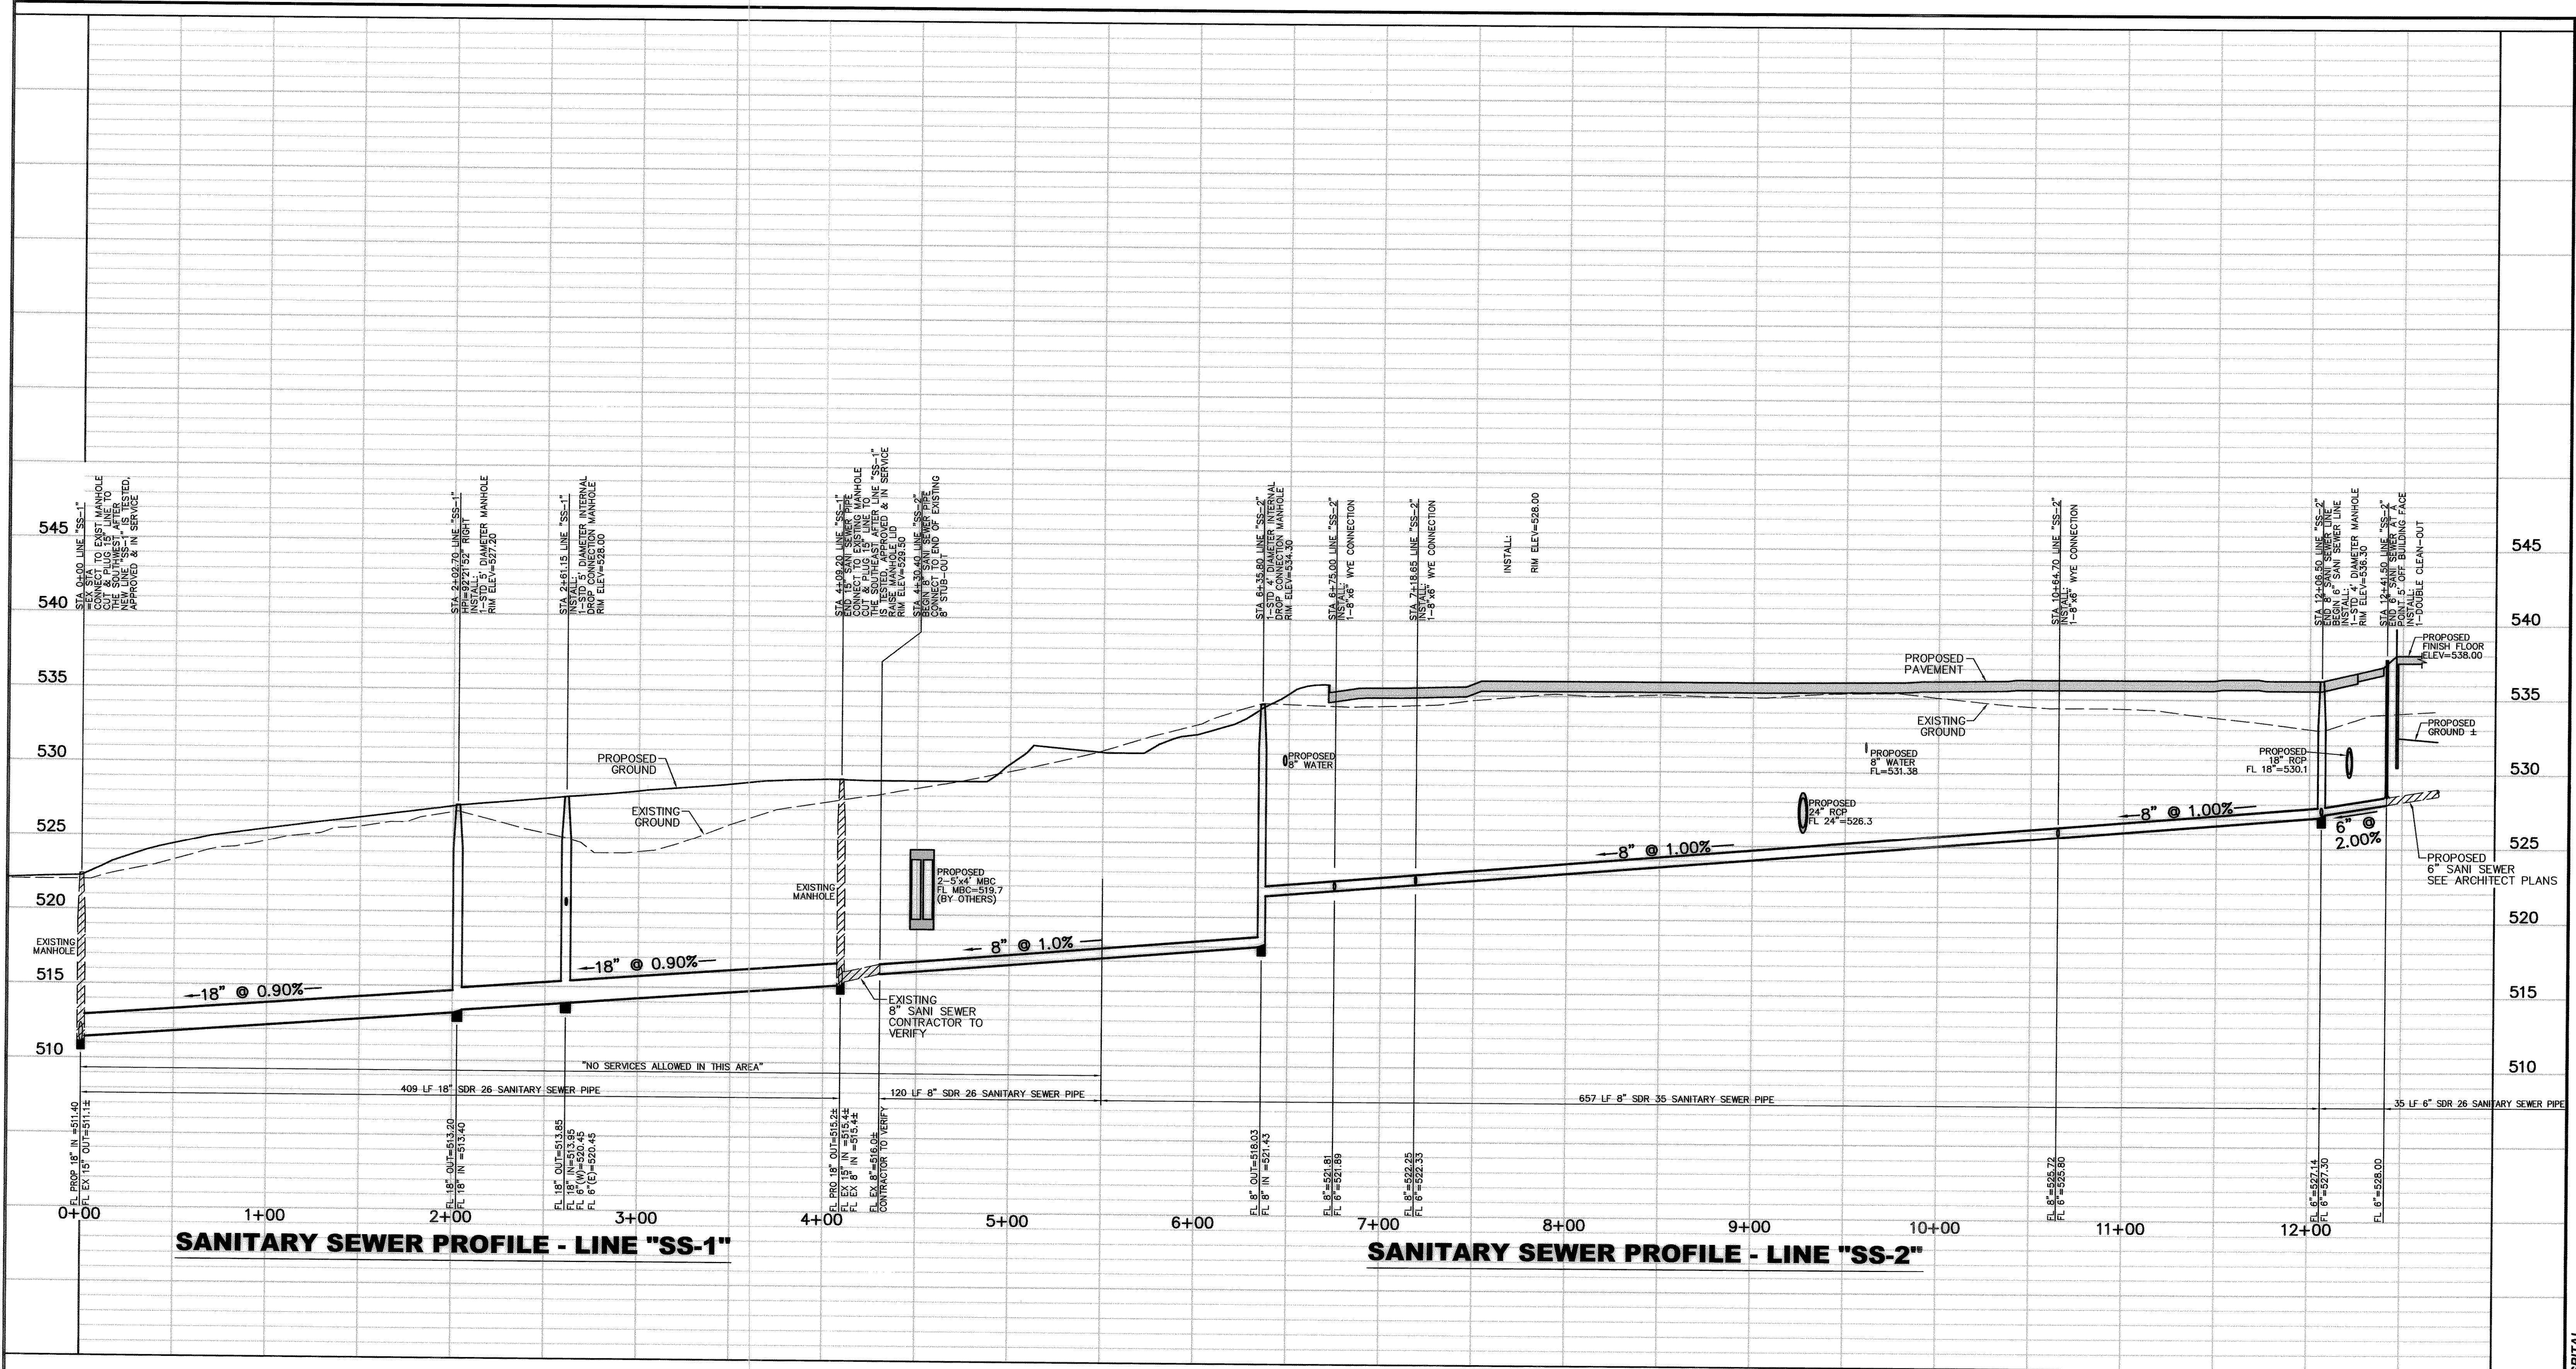
SANITARY SEWER PROFILE - LINE "SS-1"

SANITARY SEWER PROFILE - LINE "SS-2"

NO.	DATE	REVISION
	9/25/2006	ADDED DROP CONNECTION MANHOLE AND CHANGED SLOPE FROM STA 4+30.40 TO 6+35.80
