RECORD DOCUMENT
 This Record Document (As Built) has been prepared based on information provided by others. The Engineer has not verified the accuracy and/or completeness of this information and shall not be responsible for any errors or omissions which may be incorporated herein as a result.

CHANNEL PLAN & PROFILE

LOT 22R
SKYVIEW COUNTRY ESTATES No. 3
ROCKWALL COUNTY, TEXAS

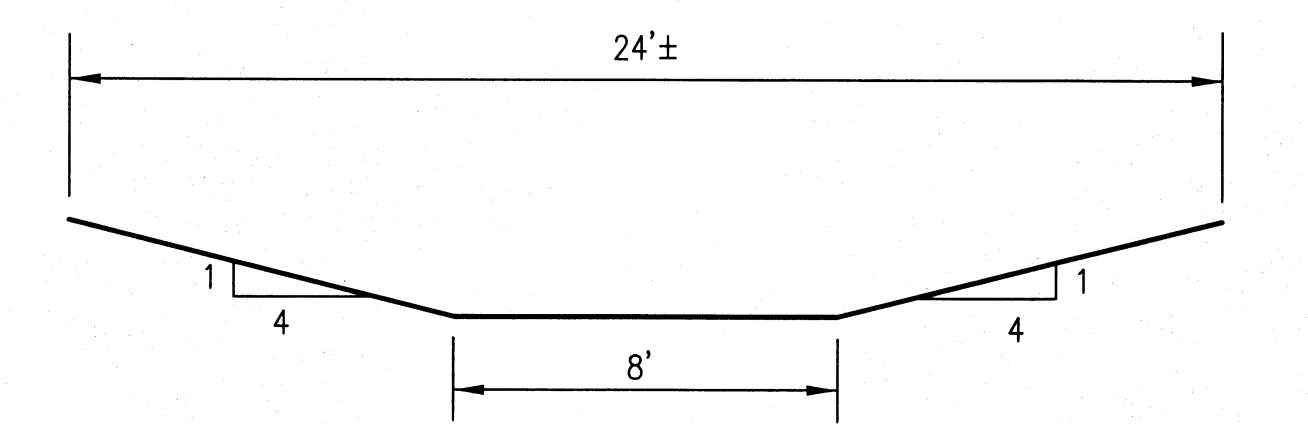
CHANNEL SECTION 'A-A'

S=1.6%
 $Q_{100}=129.27$ C.F.S.
 $V_{100}=6.33$ F.P.S.
 $d_{100}=1.47'$
 $n=0.030$

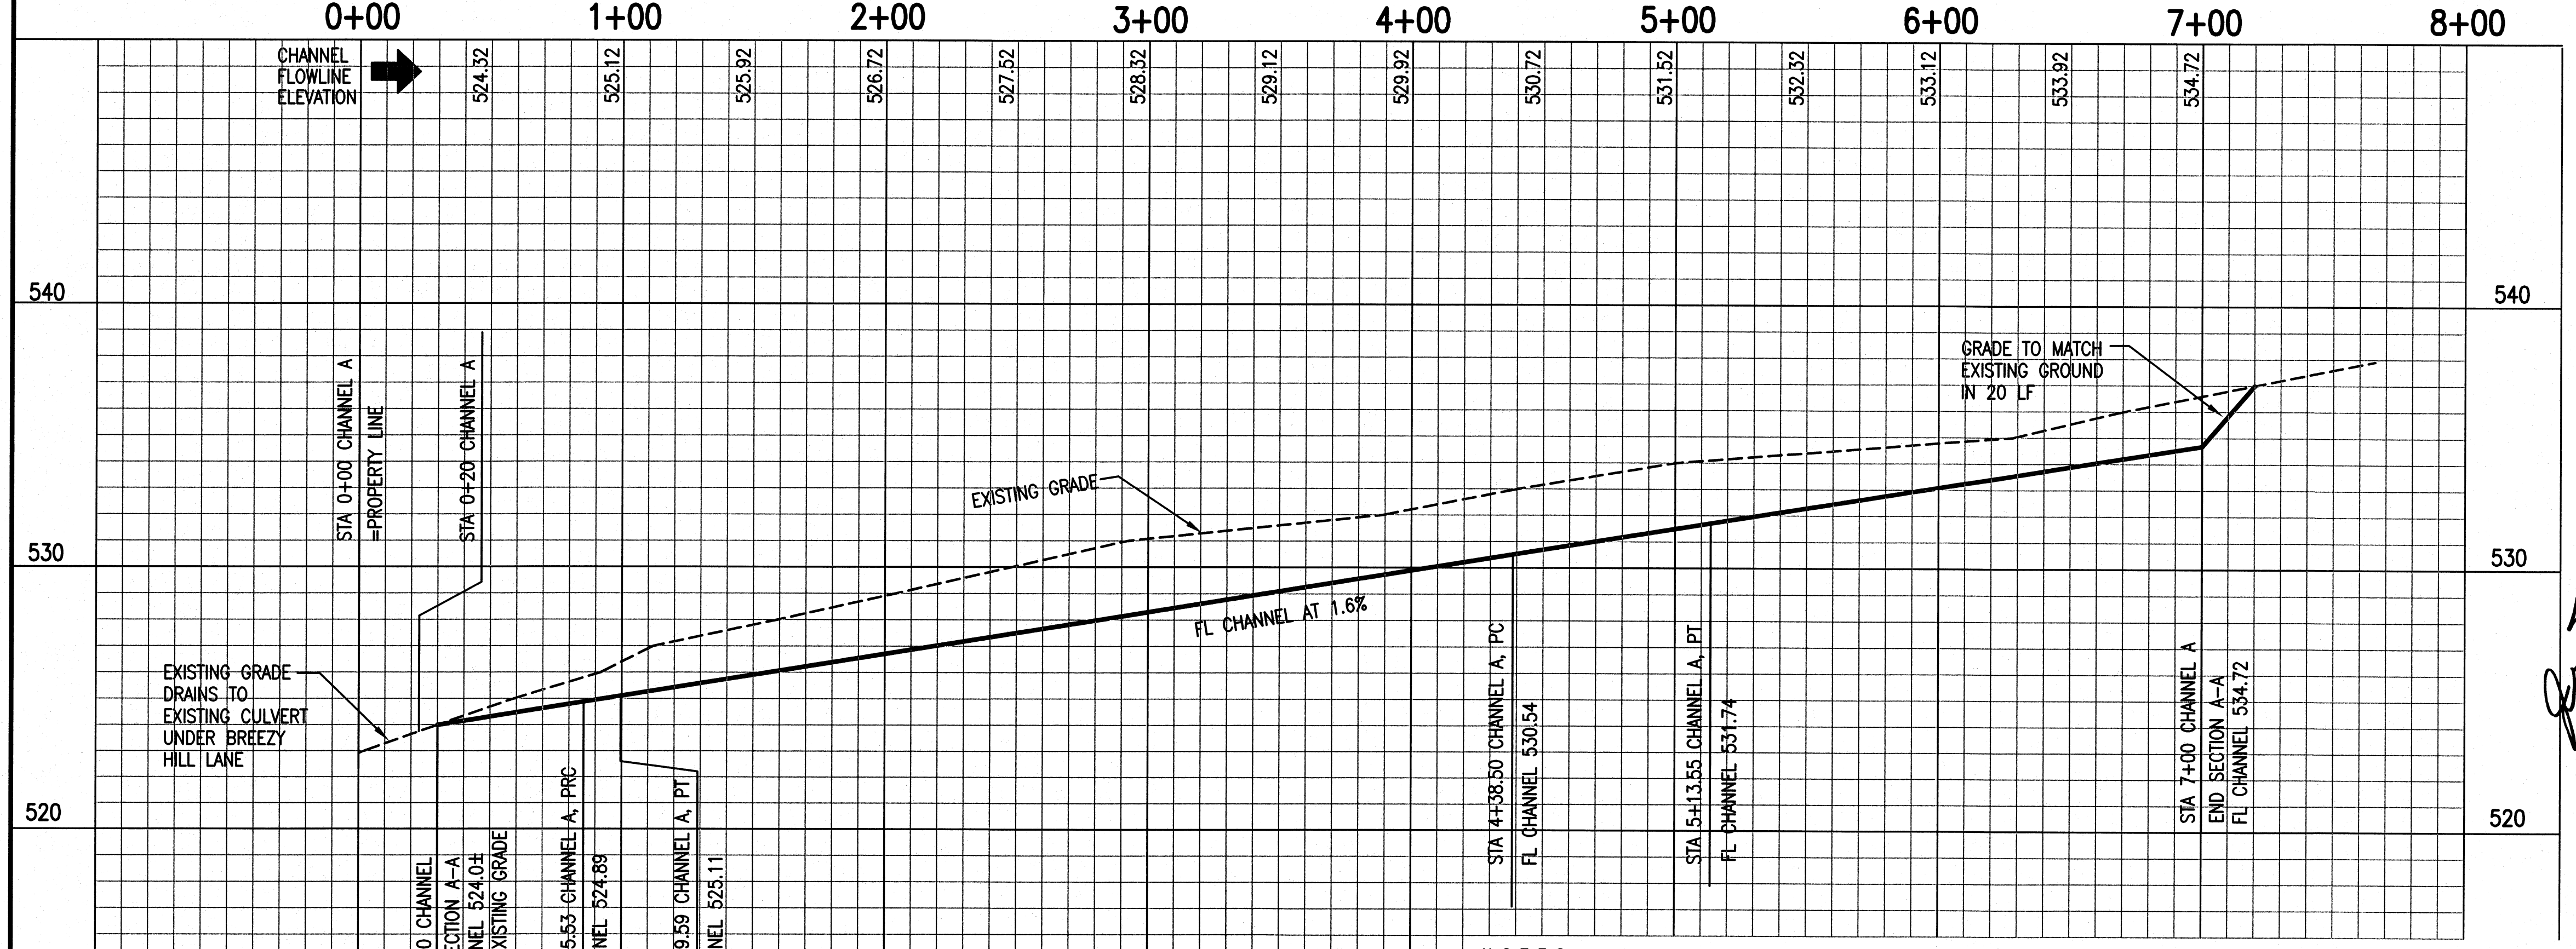
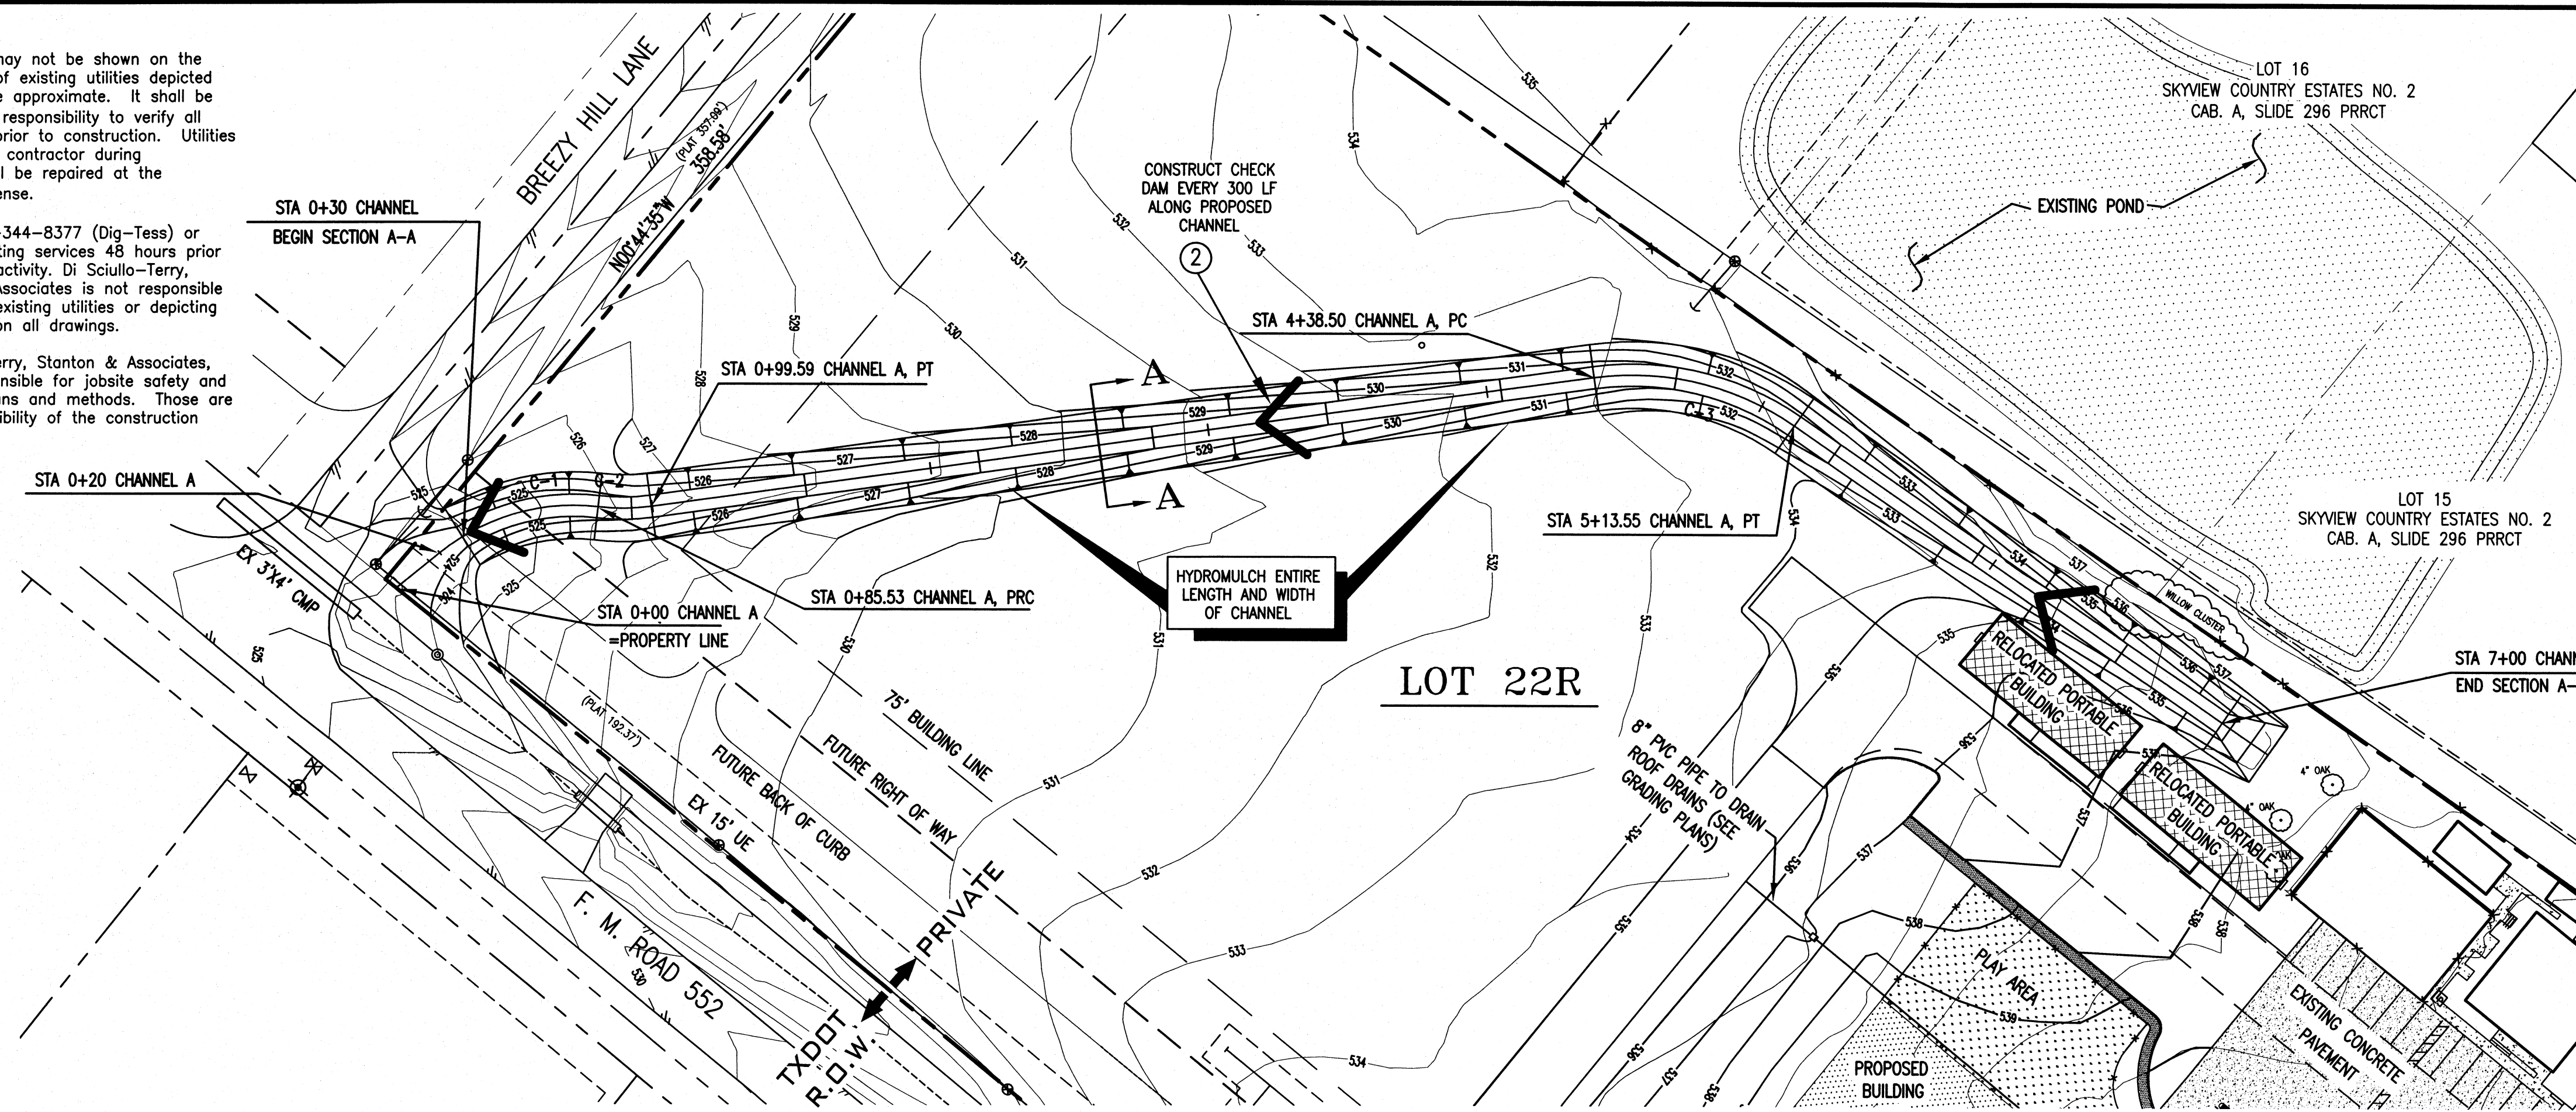
No.	DELTA	RADIUS	LENGTH	CHORD	TANGENT
1	46°14'17"	75.00'	60.53'	58.90'	32.02'
2	14°33'35"	75.00'	19.06'	19.01'	9.58'
3	43°00'00"	100.00'	75.05'	73.30'	39.39'
