DI SCIULLO-TERRY, STANTON & ASSOCIATES, INC.  
 ENGINEERING AND SURVEYING  
 401-A WEST ABRAM STREET • ARLINGTON, TEXAS 76010  
 (817) 275-3361  
 ESTABLISHED 1953 FIRM NUMBER F-615  
 TXDOT-DIMENSION CONTROL PLAN

LOT 22R  
 SKYVIEW COUNTRY ESTATES No. 3  
 ROCKWALL COUNTY, TEXAS

DESIGNED: JPS	DATE: NOVEMBER, 2011	SHEET: 4A
DRAWN: CM_JCS	SCALE: 1"=50'	
CHECKED: JPS	PROJECT No.: E-1030

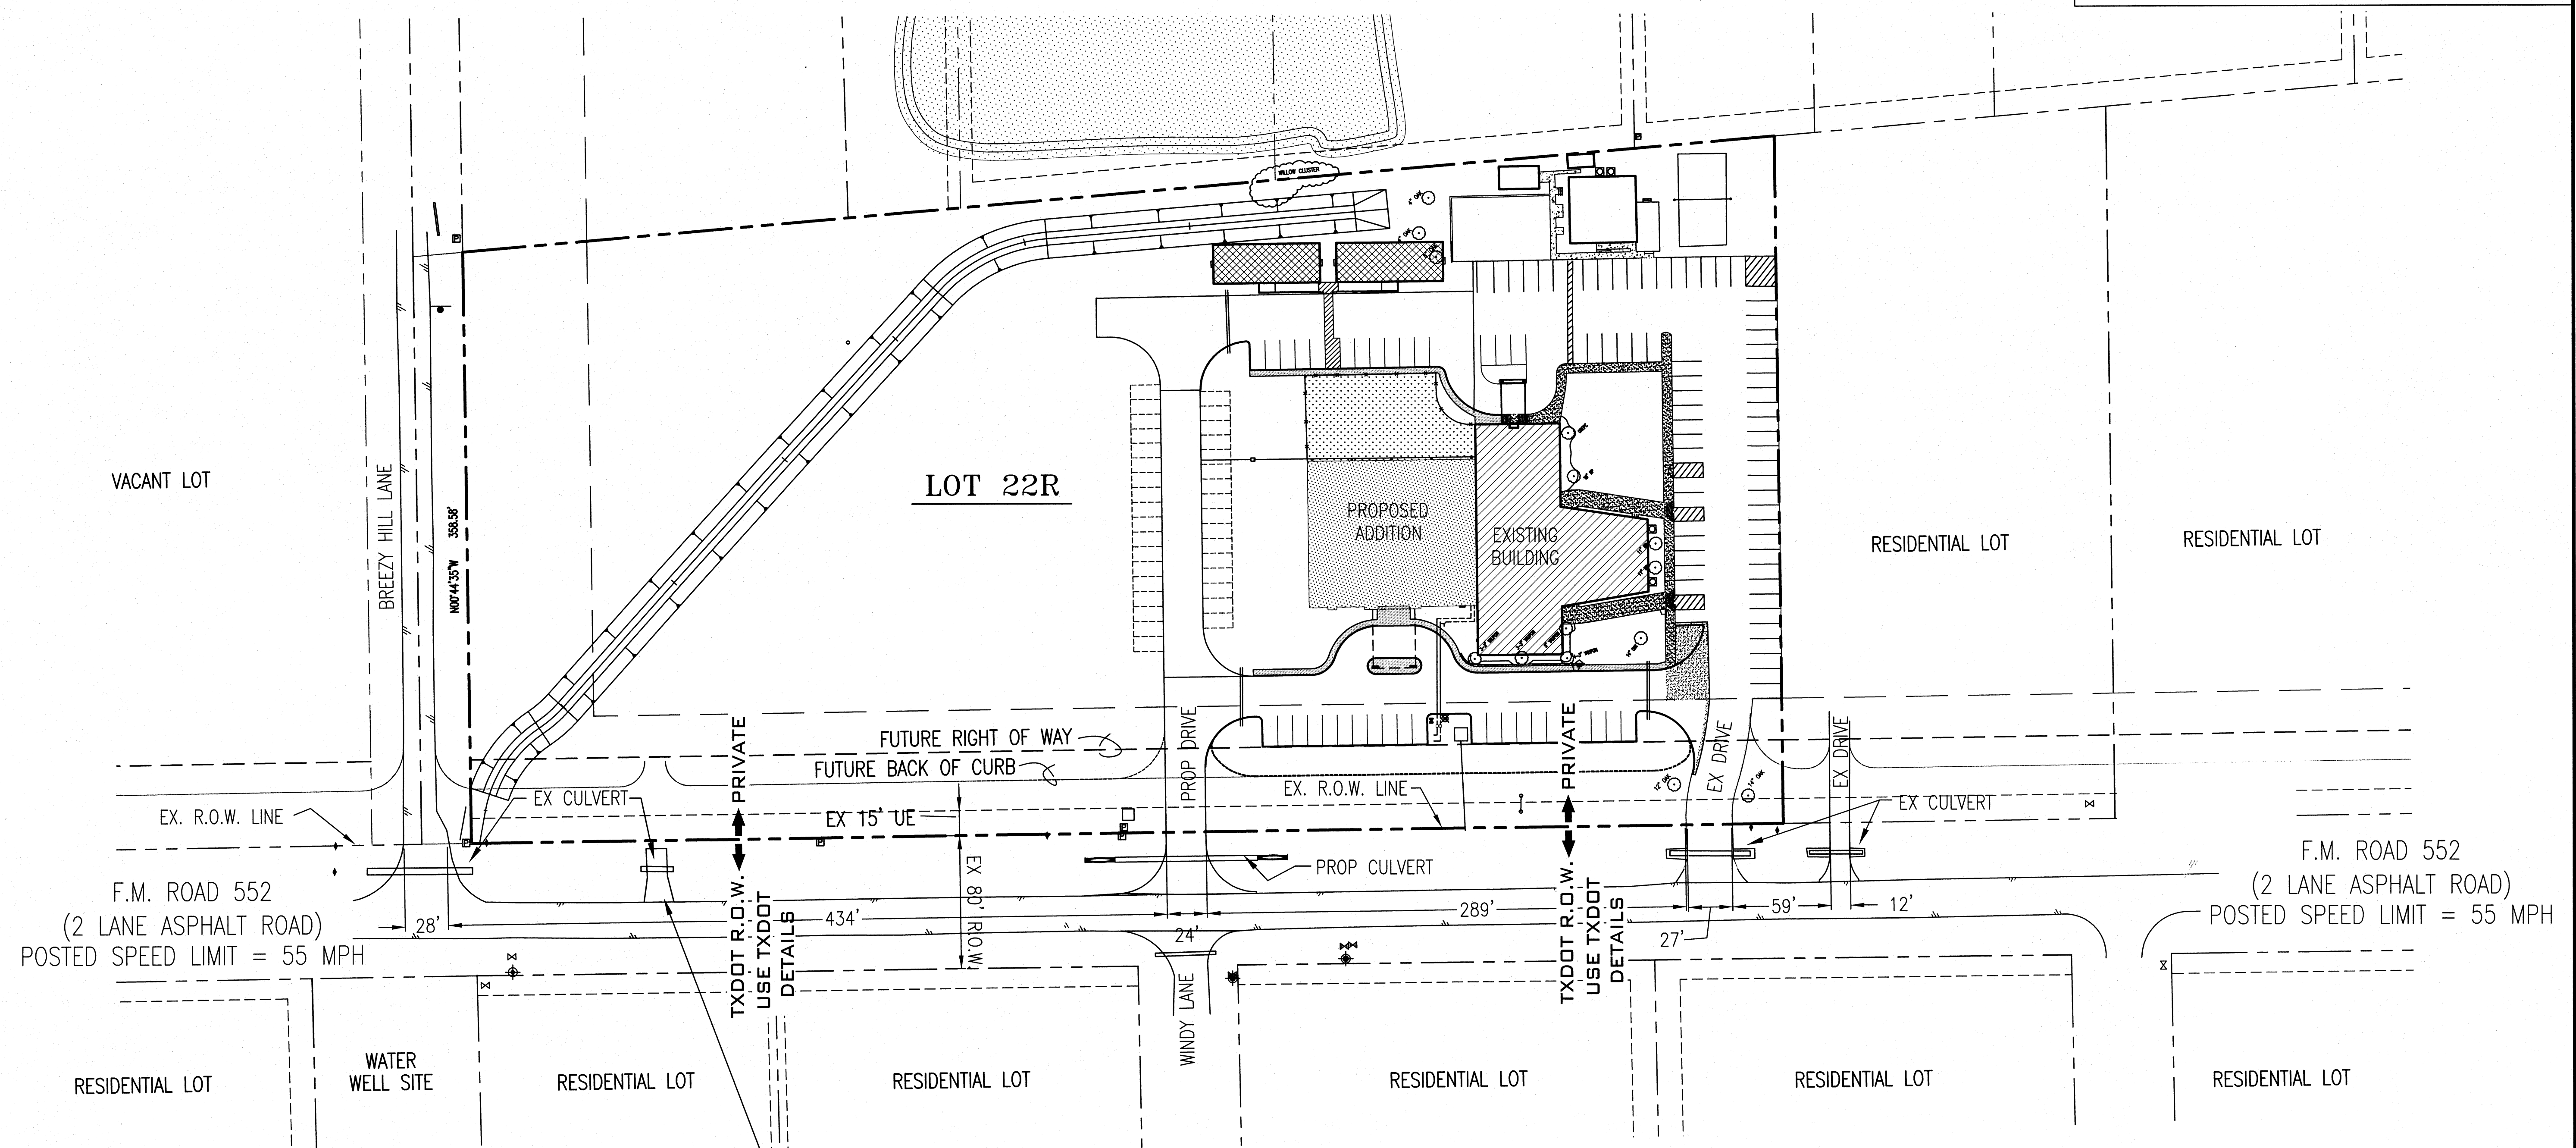
BENCH MARK:  
 BM No. 1 (Set): North rim of sanitary sewer manhole located on north side of FM Road 552, approximately 220 feet west of drive entrance to Ridgeview Church and approximately 95 feet north of west intersection of Windy Lane.  
 ELEVATION: 533.11

NOTE:  
 THIS DRIVEWAY AND CULVERT SHALL BE REMOVED AND THE DITCH SECTION RESTORED
